HARRY E. MITCHELL GOVERNMENT CENTER MODERNIZATION PLAN

May 8, 2020

TABLE OF CONTENTS

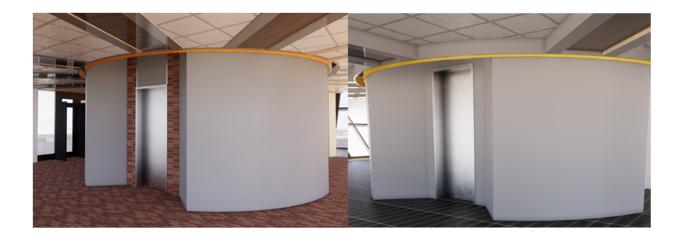
Solution:

- a. Paint the radial elements in the ceiling Dark Gray (PT03).
- b. Utilize the radial element at the core of each floor for wayfinding and paint the underside (inners) of the element the accent color.
- c. Maintain brick at elevator/core wall on the Plaza Level, add a new finish above the door; paint entire circular core in PTO3.

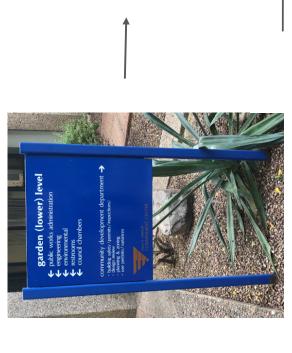
Section 4: Concepts - Complex Directional Signage

* Dasign intentforall wayfinding/Sgnage to meet ADA T1 | 5/2/2019

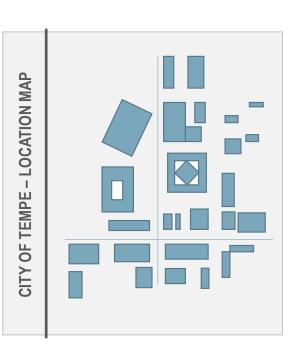
Section 4: Concepts - Complex Keyplan Signage

* Dasign intentforall wayfinding/Sgnage to meet ADA Pg. 13 | 5/2/2019

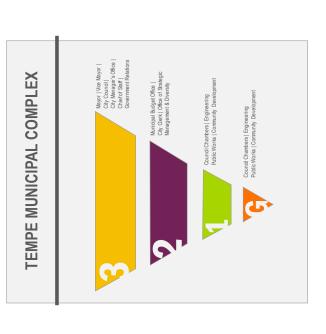
Section 4: Concepts - Complex Directory Signage

. Design inhant brall wayfinding/Sgnage to meet ADA. Pg. 14 | 5/2/2019

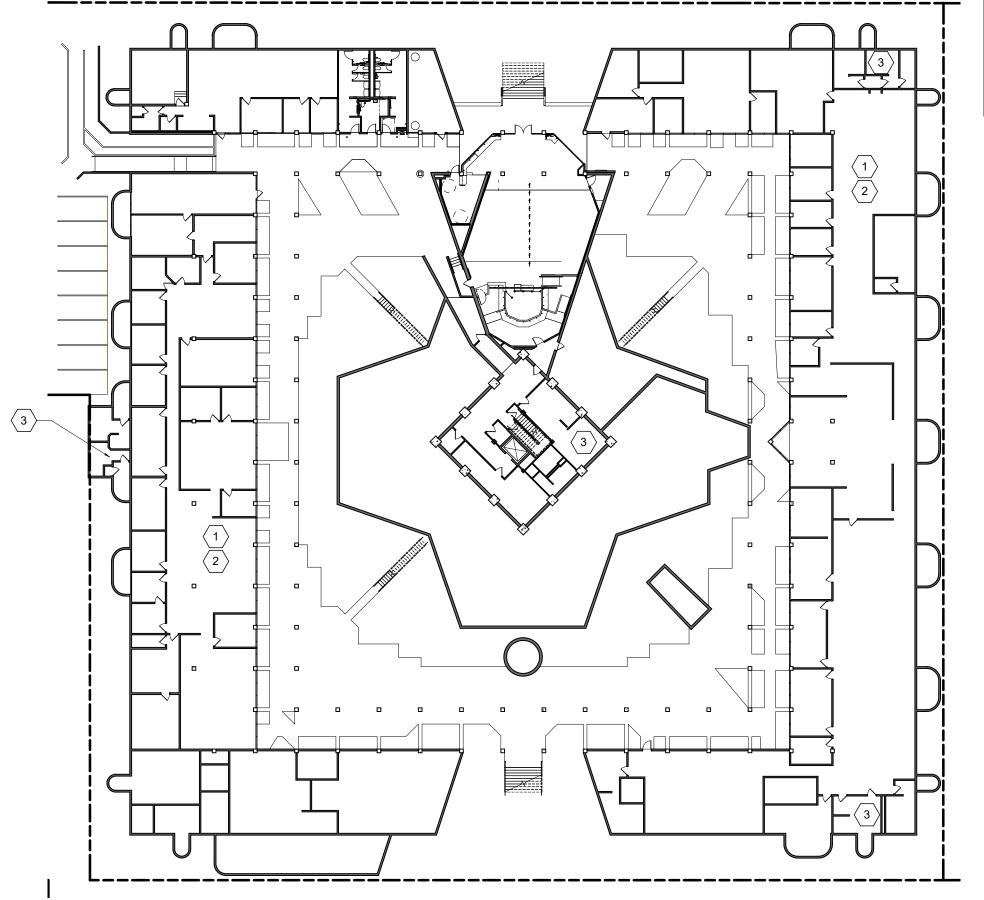
Garden Level

Update Restroom Finishes. Revise The Fixture Layout As Needed To Bring The Space Into Compliance With The Americans With Disabilities

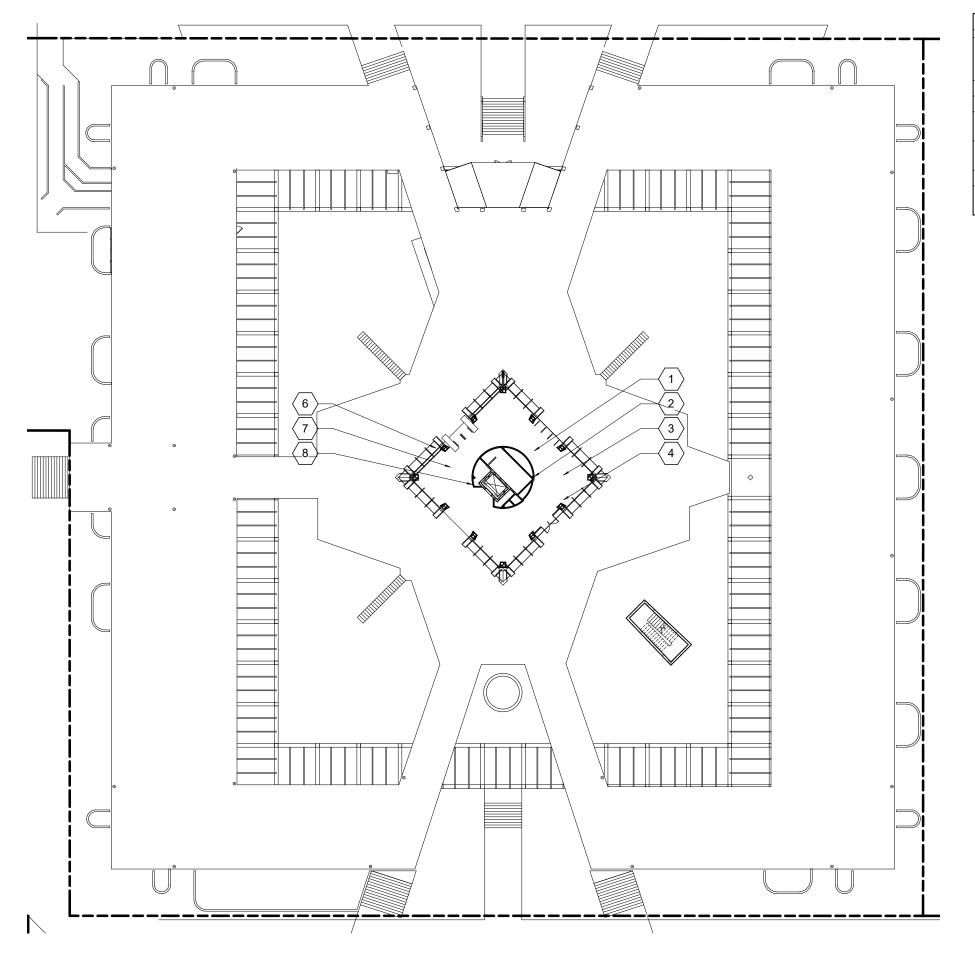
Plaza Level

Improvement Opportunities										
Develop Space Standards To Maximize Buildi Utilization And Increase Small Item Storage Capacity											
2	Elevator Core Improvements To Aid In Wayfinding										
3	Modify Linear Ceiling Elements To Reduce Glare										
4	Replace Lighting Throughout With LED Fixtures To Reduce Energy Consumption										
6	Update Window Treatments By Removing Vertical Blinds And Replacing With Window Films										
7	Clean The Brick Floor In The Tower Lobby										
8	Utilize The Walls In The Lobby To Reinforce City Of Tempe Branding And History
